Are asymmetric metal markings on the cone surface of ceramic femoral heads an indication of entrapped debris?

Valet, Sebastian; Weisse, Bernhard; Kuebler, Jakob; Zimmermann, Martin; Affolter, Christian; Terrasi, Giovanni Pietro

BioMedical Engineering OnLine 13, <https://doi.org/10.1186/1475-925X-13-38>

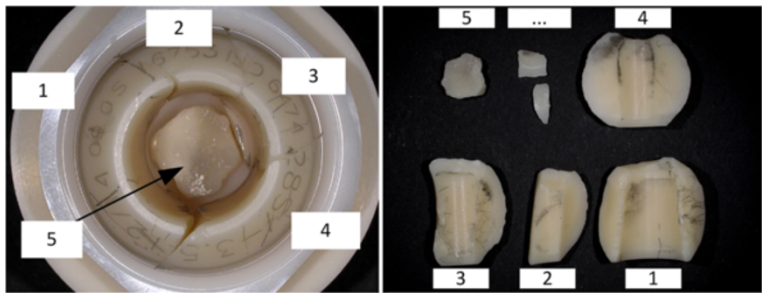
Analyses of in vivo fractured ball heads have repeatedly shown asymmetric metal markings on the conical surface of the ceramic fragments [15-18]. Figure 1 shows a typical case of an in vivo fracture of an alumina ceramic head [19]. Inspection of the fractured alumina ball heads typically showed asymmetric distribution of metal marking, resulting, presumably, from the motion in the taper fit interface between the titanium alloy stem and ceramic head prior to fracture (called primary metal marking). Additional metal markings (called secondary metal marking) can be caused by movement between fractured fragments and the stem as they are present on the fragments. Metal markings along fracture edges also appeared on fragments (Figure 1).

Figure 1 In vivo fractured femoral head (photograph: Metoxit AG [19]).

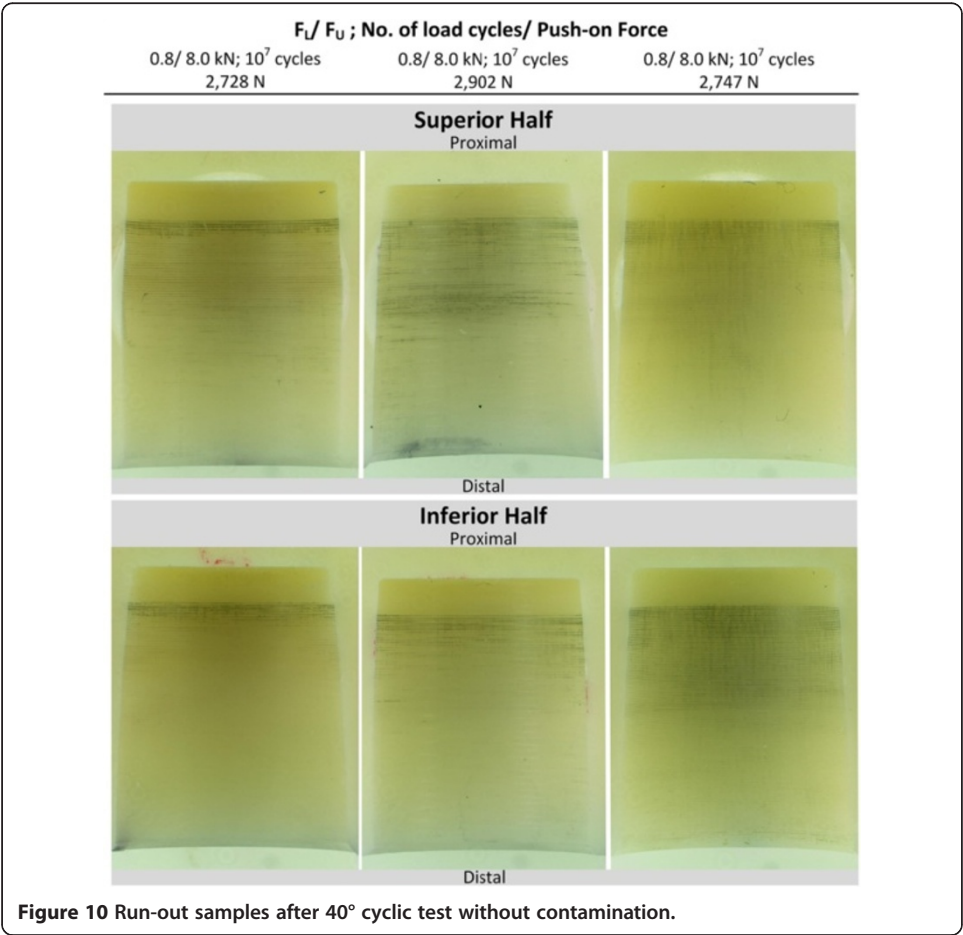
Figure 11 shows metallic marking on heads tested in a 40° configuration that had passed the run-out criterion (10 million load cycles) without failure. The average value of the force required to pull-off the heads from the differently contaminated taper was 2,041 N (n = 6, SD = 721 N, range = 2,029 N). The measured distance d_{GAP} was in a range of 2.5-2.7 mm.

- **Distribution of metal marking in circumferential direction:** A strongly asymmetric distribution of metal markings is present along the circumferential direction.
- **Distribution of metal marking along taper axis:** Two regions of increased metal markings are present. Most intense marking appear in the proximal area at the opposite cone half of the contaminant, whereas slight markings are visible in the distal area on the superior and inferior side of the head.
- **Influence of contaminant position:** If the contaminant was placed on the opposite side of the cone (from superior to inferior side) it did not significantly change the degree and distribution of the resulting metal marking.

Different types and sizes of contaminants caused a strong non-axisymmetric distribution of metal marking in all tested heads. Analysis of the samples showed that the presence of a contaminant principally results in strong metallic contact markings concentrated in two regions. This could be observed with good repeatability for all heads where contaminants were entrapped in the taper surface. However, the marking pattern of the metal was influenced by the magnitude of the applied load, as well as the size, type and position of contaminant. One region of concentrated metal markings was located on the opposite side of the contaminant position while the second region of increased metal markings was on the same side as the contaminant but on the distal side of the ball head bore. The concentration of metal markings in two regions can be explained as follows.

The occurrence of asymmetric metal markings on the cone surfaces of fractured femoral heads can be an indication that either a biological residual was entrapped in the taper fit or the stem cone was damaged prior to fracture. The entrapment of contaminants in the taper fit surface introduces an increased risk of femoral head fracture. Therefore, particular care should be taken during surgeries to assure the cone surfaces of the

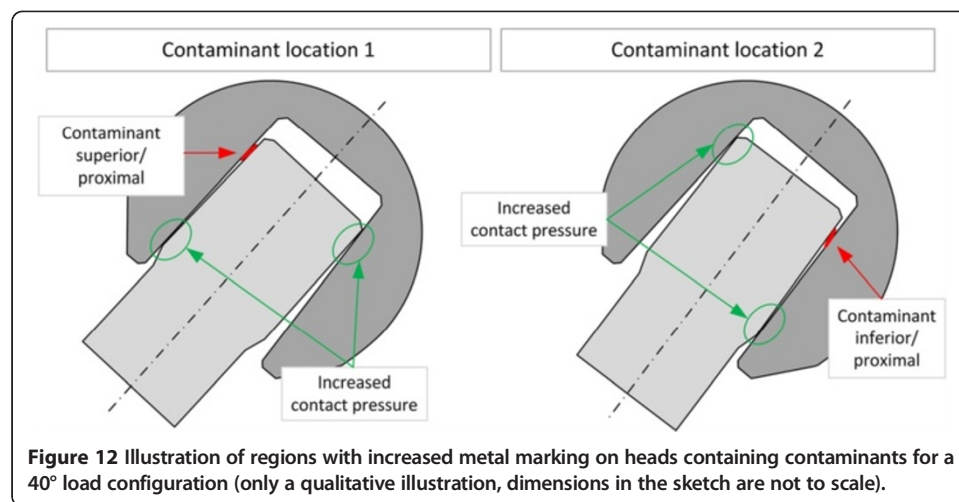
The presence of a contaminant introduces an eccentricity and misalignment between the taper axes of the stem and the conical hollow of the ball head. Thus, additional contact pressure on the distal end on one side causes a tipping of the ball, which then creates an increased contact pressure at the proximal end but on the opposite side.

Figure 12 qualitatively shows how the taper interface is affected by the presence of a contaminant. The illustrated schematic shows the taper-interface fit in a cross-sectional view along the cone axis and in the plane of the applied test load and contaminant position (Figure 12). Residuals concentrated on one position and side of the stem surface will, if not completely compressed, result in a slight tilt of the stem-cone against the cone of the femoral head. This situation increases local contact stresses in two regions as depicted in the sketch (Figure 12). As metal markings were predominant in the regions of increased contact stresses, it can be proposed that they were caused by the increase in local contact pressure in these regions.

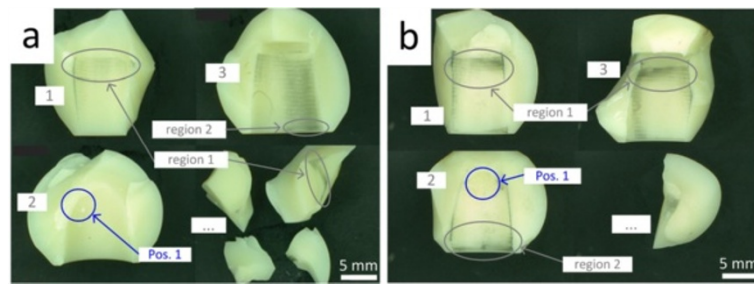
Seven of the total 18 femoral heads tested failed before reaching the test stop criterion of 10^7 cycles. Four of those seven heads (test no. 5, 7, 14 and 15) were selected for a first failure analysis which revealed that the heads had a common failure pattern. Independent of the contamination position (1 or 2) between stem and head bore and as a result of the loading configuration a main fracture fragment with spherical calotte shape was detached from the superior half of the heads (Figure 13a). For a more in-depth failure analysis the femoral heads with the lowest number of load cycles till failure (test no. 15, $<10^3$ cycles) and the one with the highest number (test no. 5, $3.28 \cdot 10^6$ cycles) were selected, Figure 14. Figure 13b and Figure 13e show the main fracture fragments of the two heads with arrows marking the fracture origins. On the main fracture fragment of test no. 15 two white spots could be seen in the bore and one covering the failure origin. The spots originated most likely from the salt in the Ringer-solution in which the tests were conducted at a temperature of 37°C and could be removed easily with lukewarm water. That femoral head failed from a large pore connected to a granule which had not been destroyed during pressing of the ceramic green body, Figure 13c and Figure 13d. The other head (test no. 5) failed from a porous region, Figure 13f. In the porous region loose, slightly necked or aggregated grains with a diameter in the range of 0.5 to 1 μm could be found, Figure 13g. In a back scattered (BS) electron microscope image almost no difference in the grey levels of the grains and the surrounding Al_2O_3 ceramic can be seen, insert in Figure 13g.

Figure 13 Fractured ball heads selected for in-depth fractographic analysis. **a)** Test no. 15 (<103 cycles) and **b)** Test no. 5 (3.3 106 cycles). "Region 1/2" designates the regions of increased contact pressure for the presence of a contaminant.

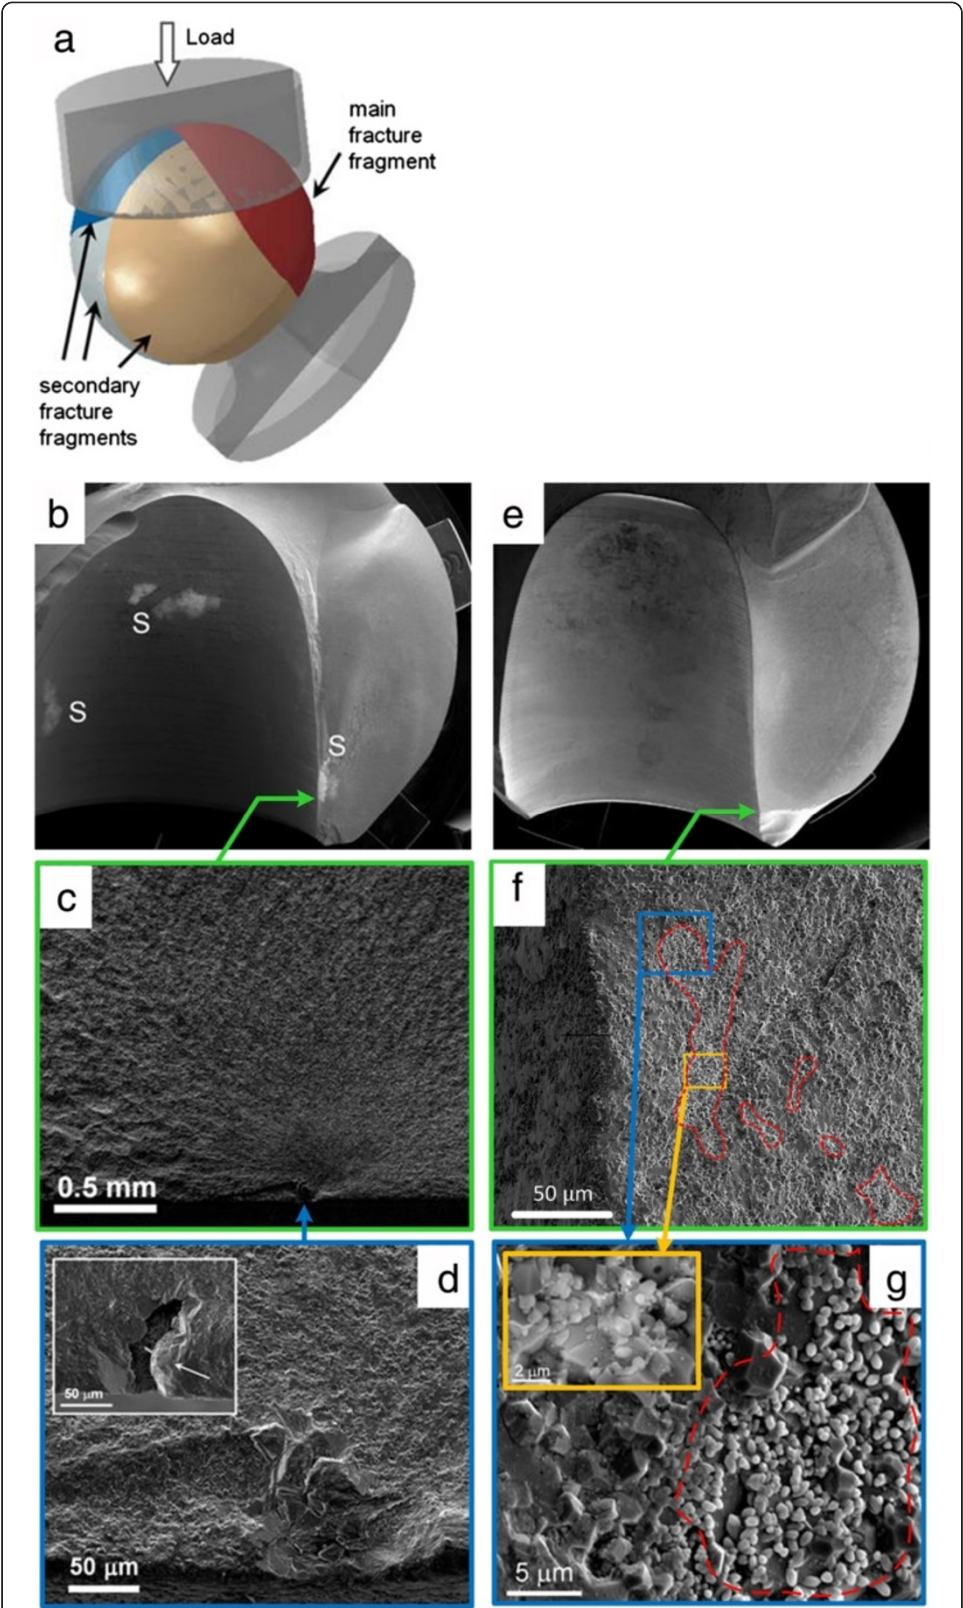
With the failure relevant defect size (depth) in test no. 15 which is, based on the fractographic images, roughly $a = 120 \mu\text{m}$ and the Griffith equation [34] it is possible to estimate that the relevant stress σ at failure had been about in the range of 280 MPa. For test no. 5 it was not possible to estimate a relevant failure size fractographically.

Fracture of samples at the beginning of the cyclic testing may be attributed to either static overloading during the increase of the cyclic test load or to low cycle fatigue due to subcritical crack-growth. In either case stress concentration induced by the contaminants are likely to have contributed to the failure. Asymmetric metallic traces found on the fragments of the in-vivo fracture as well as of the ball head fracture under asymmetric test conditions are an indication of an asymmetric contact pressure distribution. This asymmetry can be caused by the presence of contaminants resulting in locally increased contact stresses. In this study, all tested heads containing different types and sizes of contaminants exhibited significant asymmetric distribution of metallic marks on the conical surface. Contaminants such as bone chips, soft tissue or blood entrapped in the taper fit were reported to lower the fracture load in a test according to ISO 7206–10 by up to 90% [9,11]. The types of fracture observed in the failed heads of the present study were similar to the typical bore failure as reported for a static axisymmetric burst test [1].

Therefore, we suppose that the failure of the ball heads was caused by an increase of the maximum stresses in the ball head due to the presence of the contaminants. Additional analysis would be needed to quantify the increase of maximum stress if a contaminant is entrapped in the taper fit. This analysis may be conducted in a separate study.

Figure 14 Fractographic analysis. **a)** General fracture behaviour of ball heads failing before reaching 107 fatigue cycles. **b, c, d)** Test Nr. 15 (<103 cycles) and **e, f, g)** Test Nr. 5 (3.28*106 cycles) **b, e)** Main fracture fragment (fish-eye mode). Arrow marks fracture origin and S salt scales. **c)** Arrow marks fracture origin. **d)** Fracture origin magnified. Insert: opposite fracture surface. Arrow marks a granule, attached to large pore. The granule had not been destroyed during pressing the green body. **f)** Fracture origin magnified (circular line marks area in which porous regions were found). **g)** Magnified area showing a fine grained contamination. Insert: Magnified area BS shown in BSE mode.
