In situ measurement of bedrock erosion

Rieke-Zapp, D.H.; Beer, Alexander R.; Turowski, Jens M.; Campana, Lorenzo

International Archives of the Photogrammetry, Remote Sensing and Spatial Information Sciences XXXIX(B5), <https://doi.org/10.5194/isprsarchives-XXXIX-B5-429-2012>

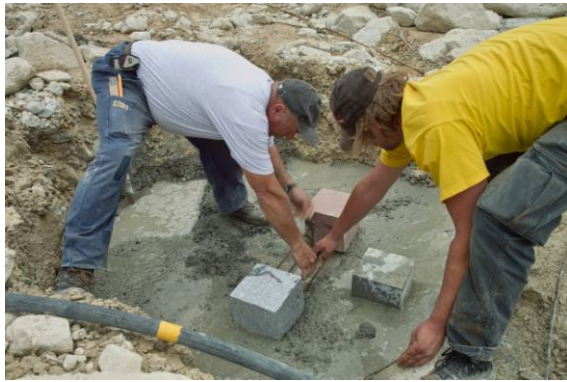
Figure 1. Installation of rock samples at the Illgraben site.

The Illgraben catchment contains one of the most active debris channels in Europe. Over the last years three to five debris flows per year occurred (McArdell et al., 2007). Debris flows reach a volume of up to 30'000 m³ per event (summer 2010). Rock samples were placed in a concrete block and fixed to a check dam in the centre of the debris flow channel (Figure 1). The placement was below the crest of the check dam as a similar installation was carried away during the previous field season. Dimensions of the samples was 0.2 x 0.2 x 0.2 m³. The rock samples represented three different lithologies – marble, granite, and sandstone – with different grain size, different hardness, and different texture. While grain size and hardness will have an impact on the recorded abrasion rate, texture of the

rock samples plays an important role for identification of homologous points using stereo photogrammetry. The expected abrasion in this environment was assumed to be more than a millimetre per event and thus much larger than the average denudation rate in the European Alps. Rock samples were installed in June 2010. Measurements took place 8th July 2010 and 3rd August 2010 after a large debris flow event. The rock fragments were covered by half a metre of debris allowing for an independent measurement epoch after the debris flow. During the next field season a new set of rock samples was installed level with the check dam to measure erosion. Since installation in summer of 2011, no significant debris flow event occurred. Data for comparison will be collected during the upcoming field season in 2012.

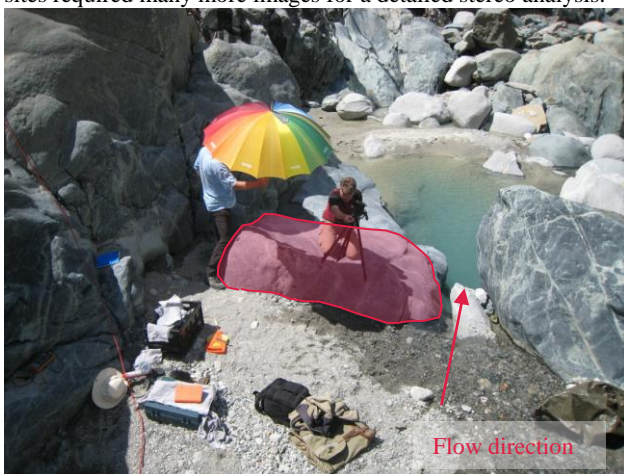
Figure 2. Data acquisition at the Gornera field site.

Two epochs from the Gornera field site (Figure 2) are available from the field season of 2011. Only the photogrammetric technique was applied in this location. The shape of the block and the much larger surface area compared to the other field sites required many more images for a detailed stereo analysis.

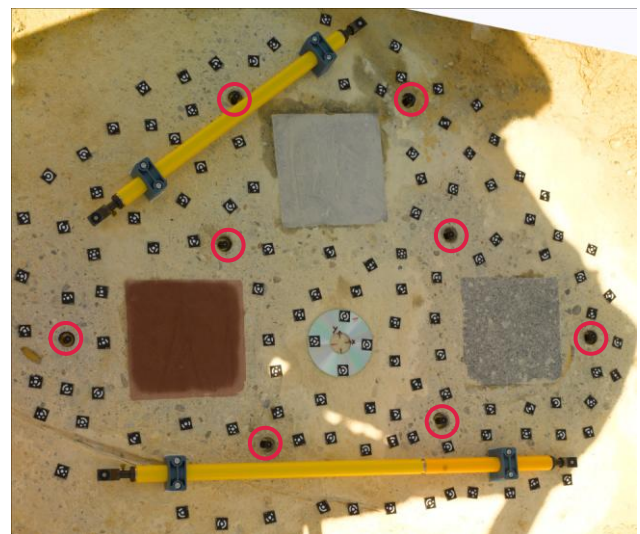
Figure 3. Photogrammetric setup for surveying of the targets at the Illgraben field site. Eight FTI target holders were embedded in the concrete (locations marked in red).

Close range photogrammetry was used for definition of a coordinate reference frame (Figure 3). Targets were placed in the FTI holders and up to 120 coded targets were distributed in the area of interest. At least two scale bars with a stack up accuracy of 0.02 mm (Brunson) were placed in the area of interest for scaling of the photogrammetrically derived coordinate system. At least 25 images were taken with an Alpa 12 Metric camera and Leaf Aputs digital camera back (Rieke-Zapp, 2010). Coordinates of the reference points were calculated using a self-calibrating bundle block adjustment in Aicon 3D Studio software (Aicon, 2011). Two different focus settings were used for image acquisition (Figure 4). The images taken further away covered many coded target points per image while the image taken from closer range had much higher resolution and were later used for stereo image matching. The two focus settings of the camera were introduced as two individual cameras in the adjustment.

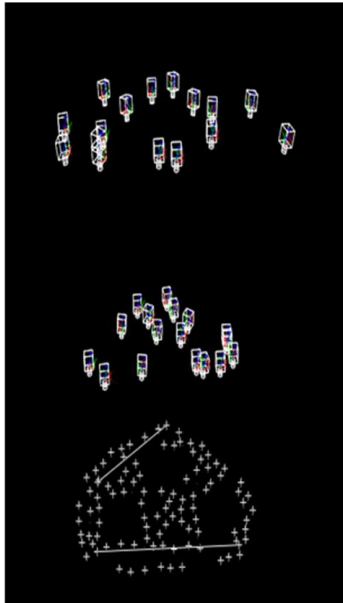
Figure 4. A combined bundle block adjustment was calculated to retrieve coordinates for the reference points as well as image orientation and camera geometry for two camera settings.

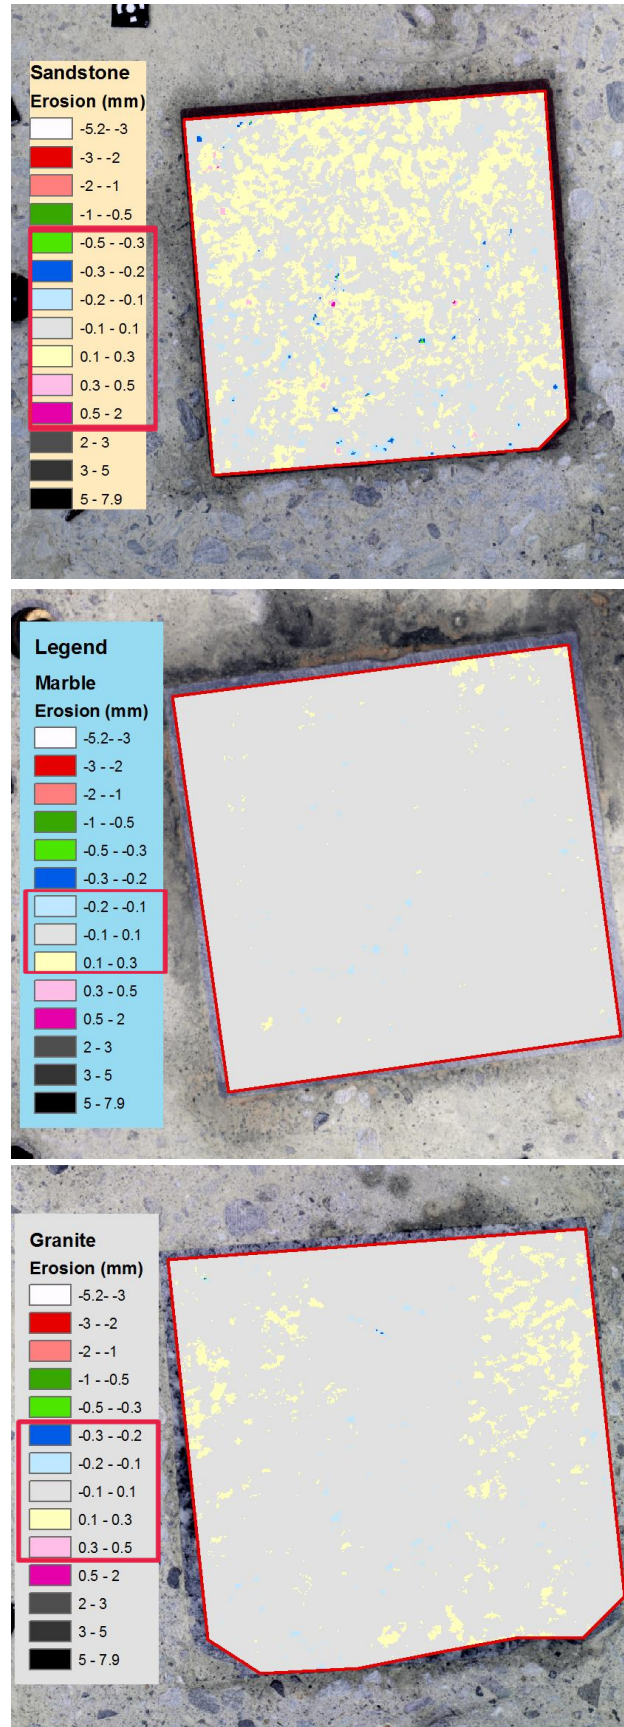
Figure 5. Difference DEMs comparing two epochs of measurements at the Illgraben site showing marginal erosion.

Close up imagery was imported in ERDAS/LPS 2010 software and pair wise image matching was performed. Images pairs were selected manually based on overlap and base distance between the images. A point cloud file was calculated from each stereo pair. The individual files were visually checked and merged using ArcGIS 10 software. Since the area of interest was typically covered in several stereo models, very dense point clouds were generated. The point clouds were combined and down-sampled to a raster with 0.5 mm² cell size applying a local median filter. The amount of abrasion for each raster cell was calculated by subtracting the elevation rasters of two epochs (Figure 5).

Results in Figure 5 and Table 1 reveal very little change on the surfaces at the Illgraben site. It is most likely that the rock samples were positioned too far below the active surface and were actually protected from erosion by the check dam. Assuming on the other hand that the rocks were not eroded, the results can be used to check the reproducibility of surface measurements between two epochs – including excavation after the debris flow. Assuming zero erosion, the standard deviation of the difference DEMs represented the precision of the analysis (Table 1). The largest standard deviation was well below 0.1 mm. All models show spots with larger elevation values compared to the previous epoch marking aggradation instead of erosion. The largest spot value for aggradation was 0.379 mm. This is best explained by sub-optimum preparation of the surface before measurement as well as the possible import of windblown dust particles – although visible, the effect is marginal considering that the data was generated under field conditions. The average change in elevation was positive (erosion) for all three plates.

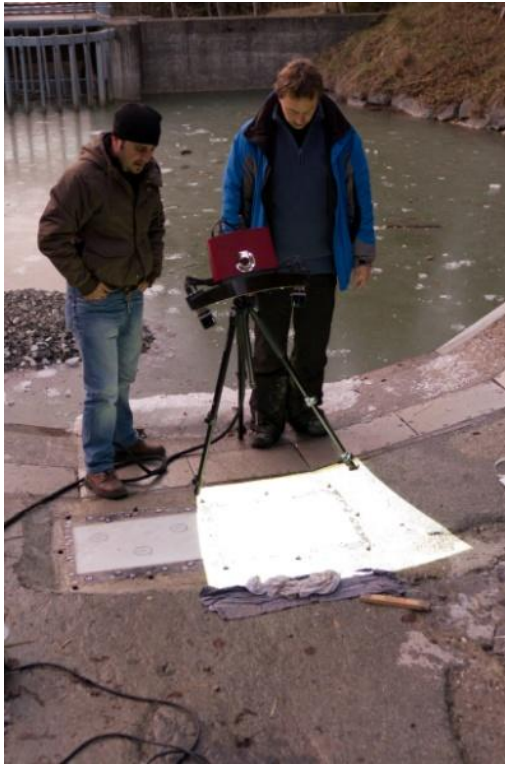
Figure 6. Structured light scanning at the Erlenbach site.

The structured light scanner was at the time of writing only used once at the Erlenbach field site (Figure 6 & 8). Data were collected at dawn as recommended for outdoor applications – only the latest generation of structured light scanners is advertised as unsusceptible to sunlight. The structured light scanner may not be practical for field use in remote areas due to the bulky dimensions, weight and the need for an external power source, but the method revealed several advantages over the photogrammetric setup. The major advantage was the speed of data acquisition and processing. A single scan was sufficient for capturing a complete rock plate with sub-millimetre resolution. Elevation values were collected for each camera pixel and results could be checked for completeness in the field. The active projection system of the structured light scanner Texture on the marble surface was hardly sufficient for photogrammetric stereo matching. In case of the structured light method texture was projected on the surface allowing easy data capture. Although data capture on the marble surface was straight forward, the resulting surface may not necessarily represent the true surface as light may penetrate to subsurface layers of the marble.

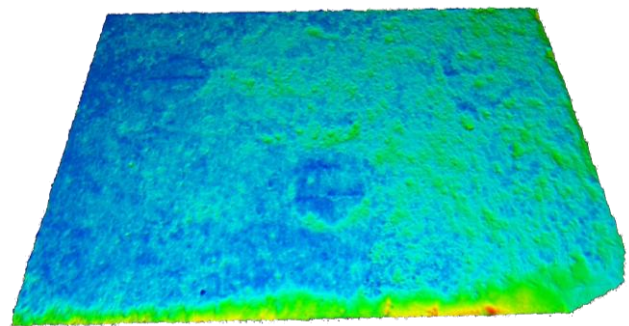
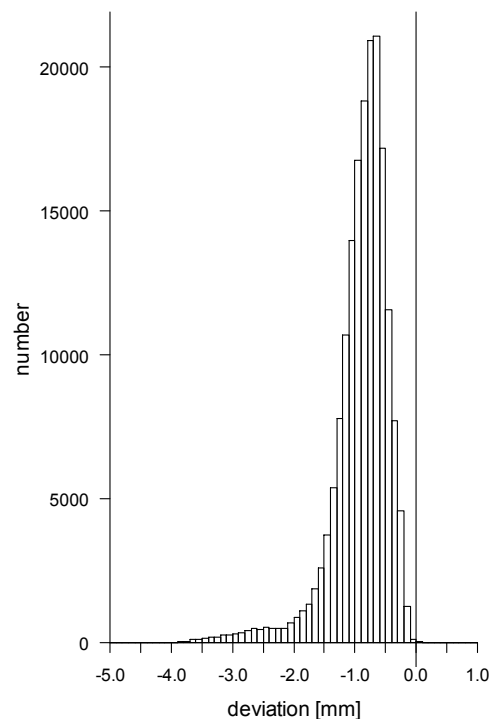
Figure 7. Difference DEM in oblique view and histogram of difference values before-after a large flow event at the Erlenbach field site.

The Erlenbach field site was surveyed twice on the same day by different operators starting the whole workflow from scratch each time. The difference DEM of the generated surfaces had a mean of 0.006 mm and a standard deviation of 0.070 mm indicating a similar level of reproducibility as for the Illgraben experiment. Measurements taken at the Erlenbach field site on 5th and 18th October 2011 captured a major flow event with 44 m³ of rock particles transported over the area of interest on 10th October 2011. More than 99.9% of the surface indicated erosion, average erosion on the concrete surface was 0.8 mm (Figure 7). Maximum erosion at exposed areas was up to 4.1 mm while flat areas revealed erosion values between 0 and 1.0 mm.

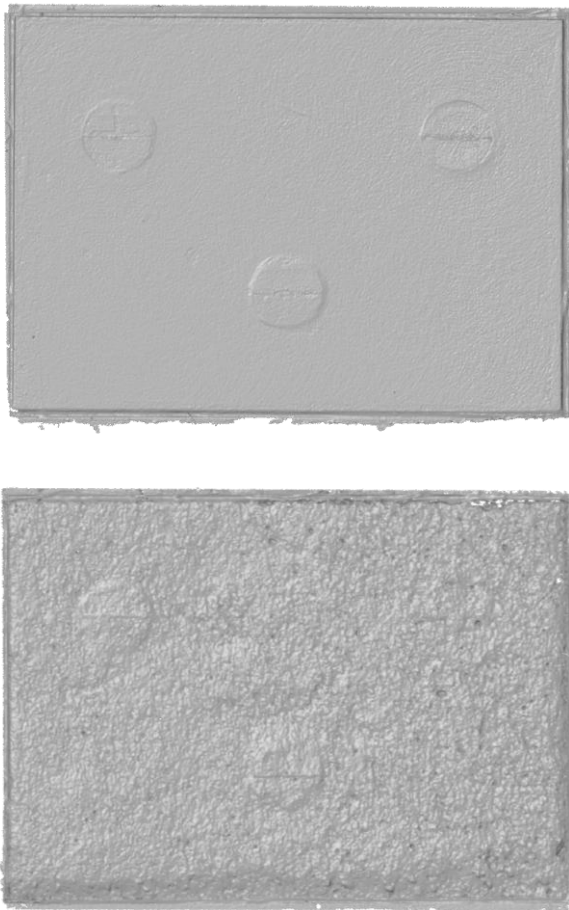
Figure 8. Structured light scanning results at the Erlenbach site. The top model shows the marble surface, the bottom model represents a concrete surface which at this point already showed erosion marks.
