The construction of the medieval domes of the Basilica of St Anthony in Padua

M. Diaz, L. Vandenabeele & S.M. Holzer

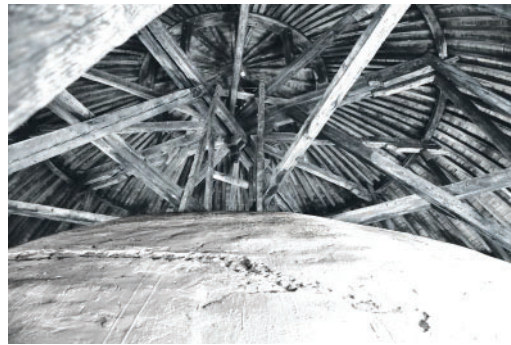
Figure 2. d02. Interior of the attic with the masonry vault and the wooden superstructure (photo: author).

Leaving aside the truncated cone of the angel dome (d04), each three-dimensional structure can be streamlined as two perpendicular frames, each composed of two diagonal struts, a short king-post and one or two collar-beams (Figure 2). In the original domes

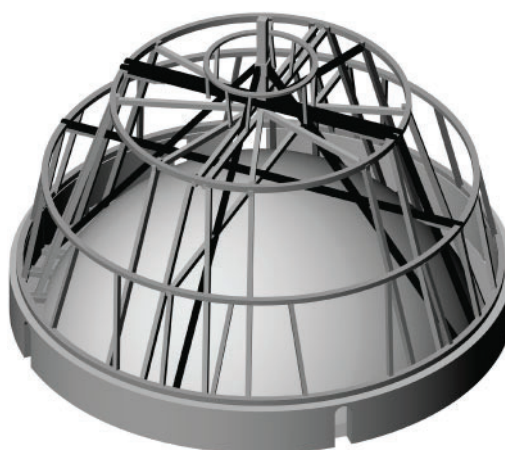
Figure 6. 3D model. Schematic identification of the dated elements during the dendro-analyses campaigns in d03. The black elements are original (3D model: author).

At this stage, the results from the first campaigns confirm the existence of beams dated back to the last quarter of the 13th century in the three considered to be the oldest domes. Due to the rare presence of bark on the elements, only two absolute datings have been obtained so far: 1282 in the dome over the Chapel of Saint Anthony (*arca* dome) (d03), and 1551 in the intermediate dome (d02). A *terminus ante quem non* has been identified for 11 other elements. As some 13th-century curves fit closely with each other, several timbers of the first construction phase could already be identified in the three surviving domes (d01, d02, d03). Two other results have confirmed the replacement of entire domes around 1750 (Pignatelli 2020). These dates thus match with the first building phase in the 13th century, with 16th-century interventions mentioned in archival documents and with the reconstruction after the fire of 1749 (Figure 6).

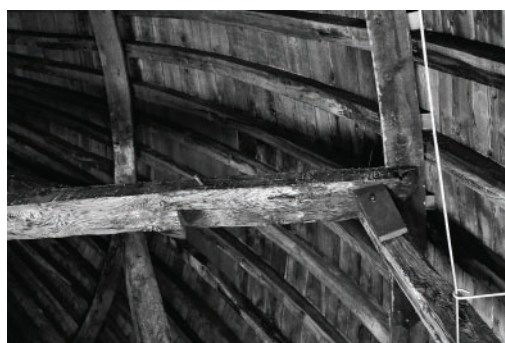
Figure 7. d02: notch visible on the bottom side of a collar-beam (photo: author).

In the most ancient domes (d01, d02, d03), notches are visible on the lower extremities of some collar-beams, at both levels (Figure 7). Since such notches are missing in the domes reconstructed later, their presence seems to identify original elements. In some occasions, these notches cover the whole width of the

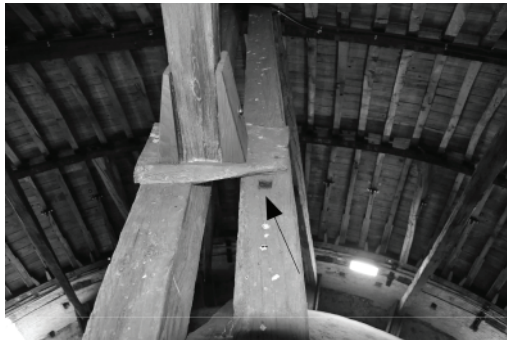
Figure 9. d02: topside of the upper collar-beam with the empty joint for the previous brace position (photo: author).

face (Figure 9). This provides evidence of the installation of previous – likely vertical – posts supporting the highest ring, another hint about the early appearance of the roofs.

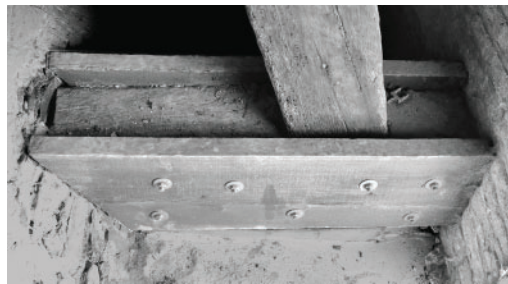
Figure 10. d01, wooden base of a strut placed between the masonry vault and the drum (photo: author).

Firstly, the bases of the timber struts rest above the start of the dome, showing that the vaulting was at least started when the carpenters set to work. Furthermore, the timber is never embedded in the masonry but completely independent, although it is likely that the short bases are not original but have been substituted due to decay, probably in the 16th century when some struts were replaced (Figure 10).

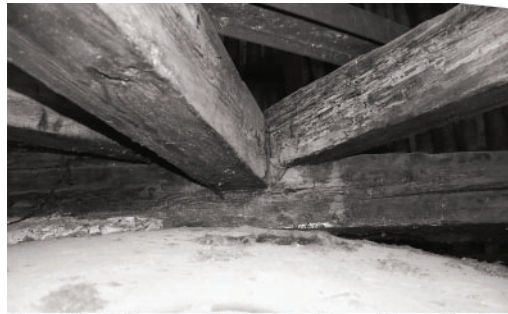
Figure 11. d01: lower collar-beam leaning on the vault's extrados (photo: author).

Secondly, the lower collar-beams of the oldest domes rest directly on the vault and do not show any deflection at the centre, which tends to indicate that the vault was there before. Also, the masonry is perfectly smooth at this point. If the timber was there before, it would have been difficult to make a regular finishing at the top of the vault (Figure 11).

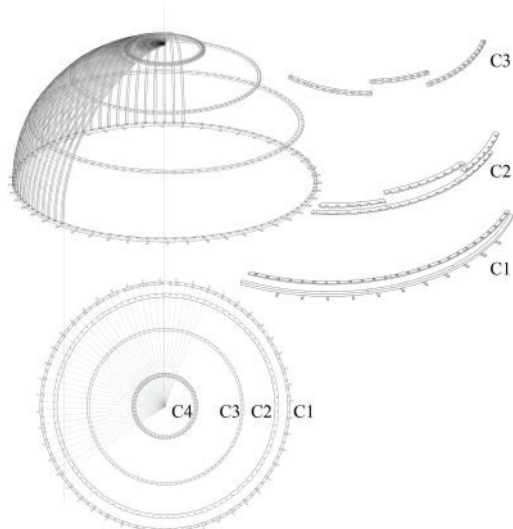
Figure 14. d02. Preassembly of the wooden rings on horizontal level. Detail of the board arrangement. C1 19th century replacement; C2 undated replacement; C3 supposed older single layer configuration (drawing: author).

The final stage would firstly consist of the placement of the wooden rings on the ends of the collar-beams, fixed with nails. The joints between the curved sections were likely shaped on the ground during a preliminary preassembly. Then, circular sectors of planks could have been lifted and reassembled on the collar-beams. Eventually, the last ring was placed after the installation of short vertical posts into the mortices, on the top side of the upper collar-beams (Figures 12j and 14).

Interestingly, in the second dome of the nave (d02), the third ring was seemingly not replaced in the 19th century. Unlike the more recent ones that are composed of two or three layers of nailed boards connected to the ribs with iron strips, it is a one-layer chain. The ribs are clamped in notches around its external profile following the probable original spacing.
