Structural analysis of unreinforced masonry spiral staircases using Discrete Element modelling

Dell'Endice, Alessandro; DeJong, Matthew J.; Van Mele, Tom; Block, Philippe

Structures 46, <https://doi.org/10.1016/j.istruc.2022.10.070>

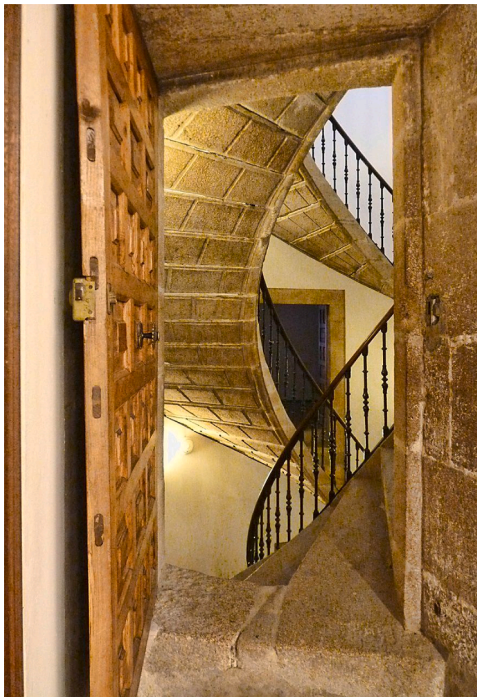
Fig. 1. Picture of a tread in correspondence of a door opening in the spiral staircase of the convent of San Domingo de Bonaval, Santiago de Compostela, Spain, XVII century.

about 10–15 cm, and only in a few cases, it reaches a length of 30 cm. This embedment length is often relatively short compared to the length of the treads, which can reach two meters. In addition, sometimes, the wall-tread area has windows or doors above, so there is no possibility to develop bending capacity in the socket (Fig. 1).

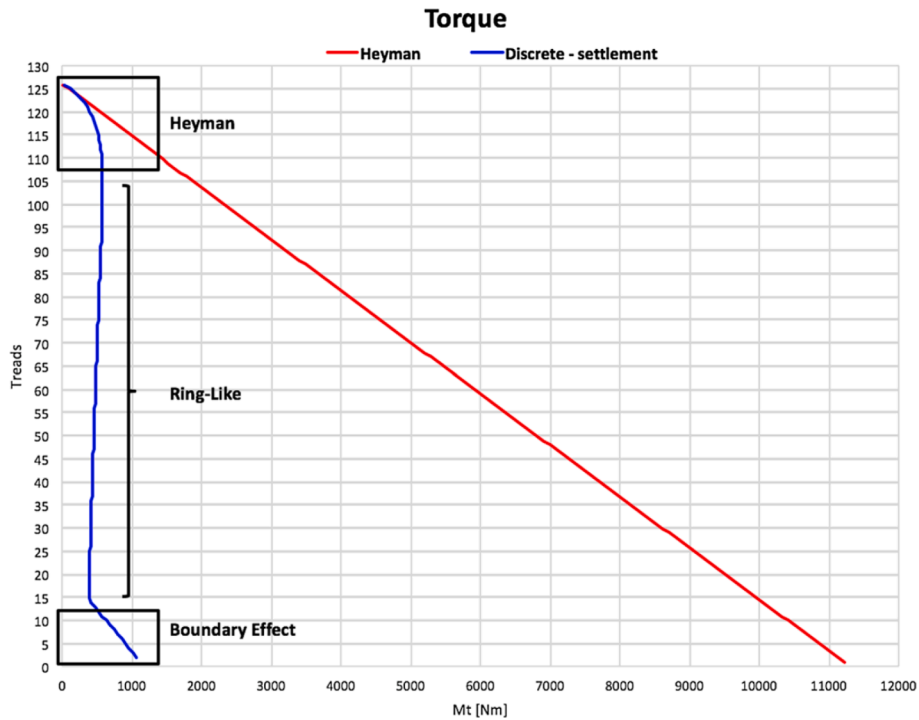
Fig. 2. Image taken from De Serio et al. [5]. Torsional moment values in the 126 treads of the spiral staircases of San Domingo de Bonaval calculated by De Serio et al. [5]. In blue, the values obtained through minimization of the potential energy, allowing settlements of the treads; in red, the torque values calculated by De Serio et al. [5] considering Heyman’s approach in Heyman [11].

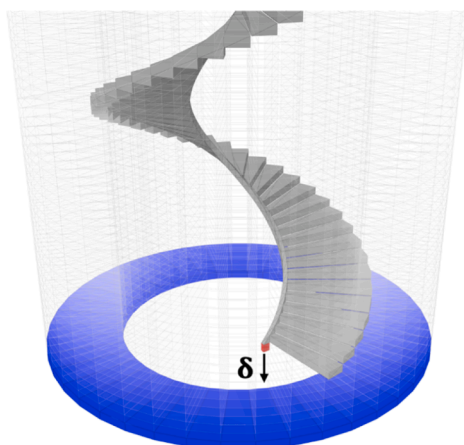
Fig. 11. Vertical displacement of the central support.

The vertical settlement of the central support (Fig. 11) has been applied to all the models with clearance and imperfections.

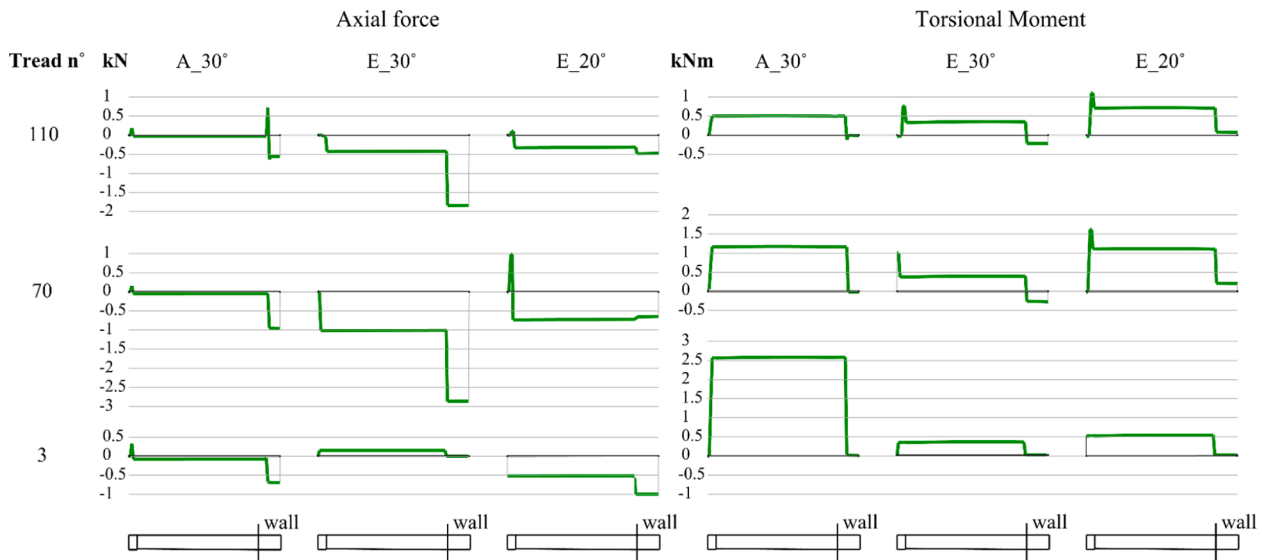
Fig. 14. Diagrams of the axial force and torsional moment for steps n3-70-110, for wall-tread conditions: “A” with friction angle 30 and “E” with friction angles 30 and 20.

numbers 3, 70, and 110, for the two extreme wall-tread conditions: “A” with friction angle 30° and “E” with friction angles 30° and 20°.

Fig. 14 clarifies how a less tight socket (“E_30°”) decreases the amount of torque and increases the axial force in the treads, as also shown by De Serio et al. [5]. On the other hand, it is interesting to notice the effect of a friction angle of 20° on case “E”. While for case “A”, with no clearance in the socket, a lower or higher friction angle did not show any variation of the internal forces, for all the other cases decreasing the friction angle causes a slight reduction of the axial force and increases the torsional moment to values comparable, for steps 70 and 110, to the one reached by case “A_30°”. As shown in Fig. 15, with a lower friction angle, forces a and b change their directions, the tread engages the lateral sides of the socket (forces e and f) and the torque increases.

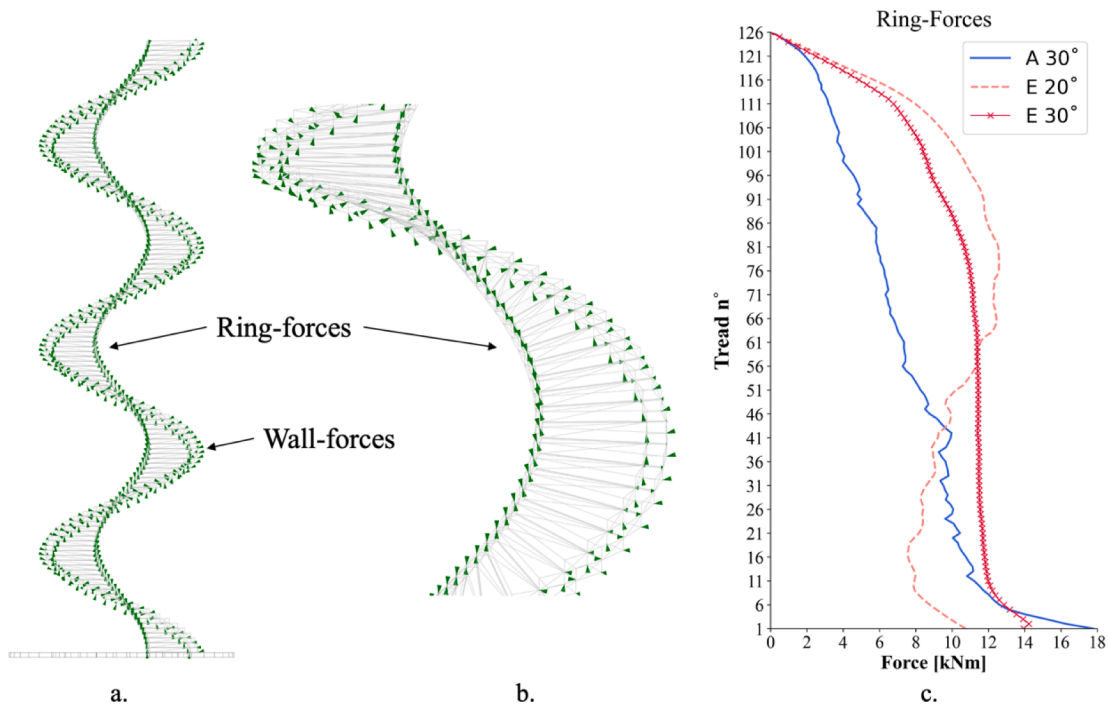
Fig. 18. a) and b) visualisation of the resultant contact forces within the treads. c) Magnitude of the resultant contact forces travelling along the central ring for case “A”, “E_20” and “E_30”.

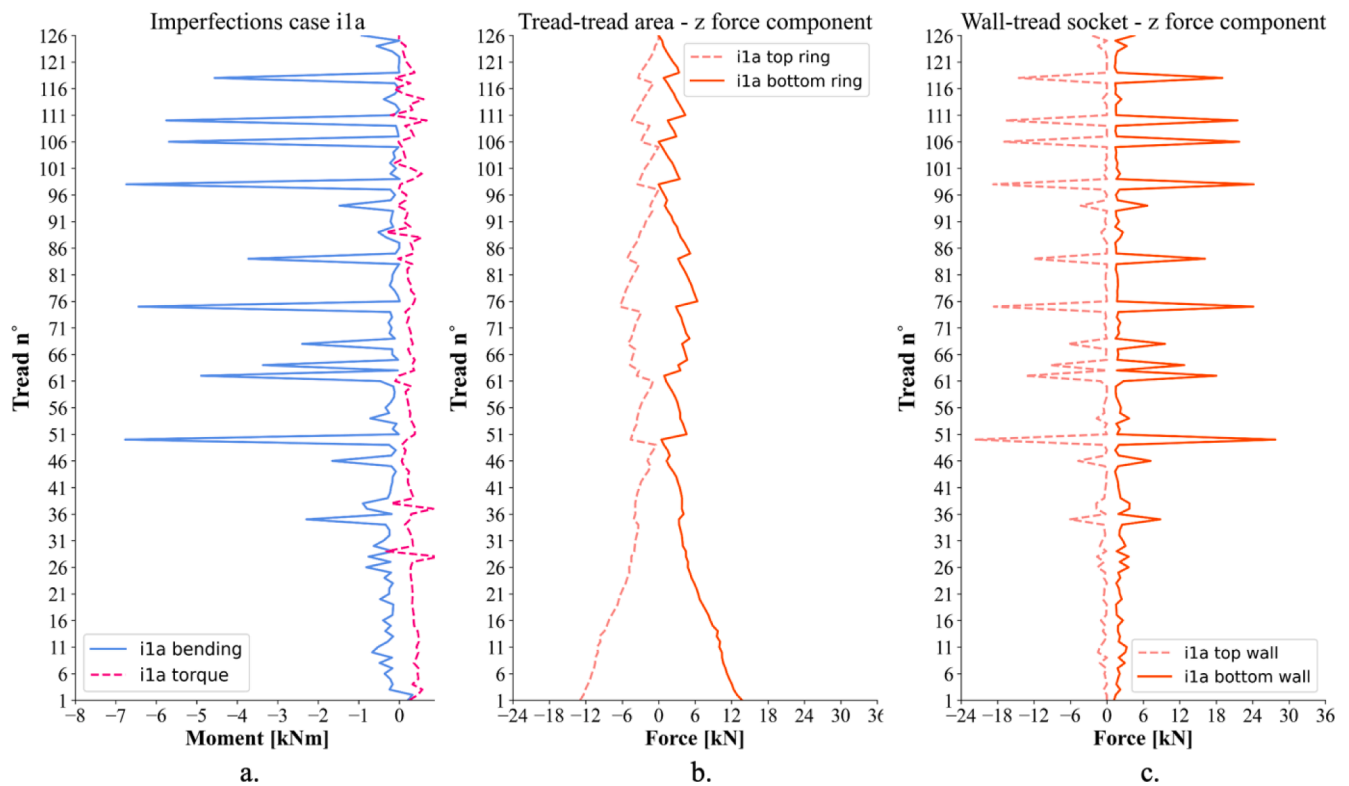
Fig. 22. a) Bending and torsional moment values in the entire staircase for case “i1a” with friction angle equal to 30. b) Magnitude of the ring forces (z component acting at the top and the bottom of each tread). c) Magnitude of the resultant wall forces (z component acting at the top and the bottom of each tread).

similar to the “A” condition. However, in other treads, the torsional moment is smaller than the minimum reached in case “E”, and is even negative at some locations. This is caused by imperfect tread-tread contact conditions which modify the location of forces **a** and **b**, inverting the torque’s sign and potentially generating local cantilever situations, which increase the bending moment at the wall-tread socket (also see Fig. 22).

Fig. 22 shows the locations of cantilever behaviour due to poor contact conditions. For example, for tread number 61 in Fig. 22a, the torsional moment is almost equal to zero, while tread 62 above has a high value of the bending moment. The same can be observed in Fig. 22b, where the z component of the force at the bottom of tread 62

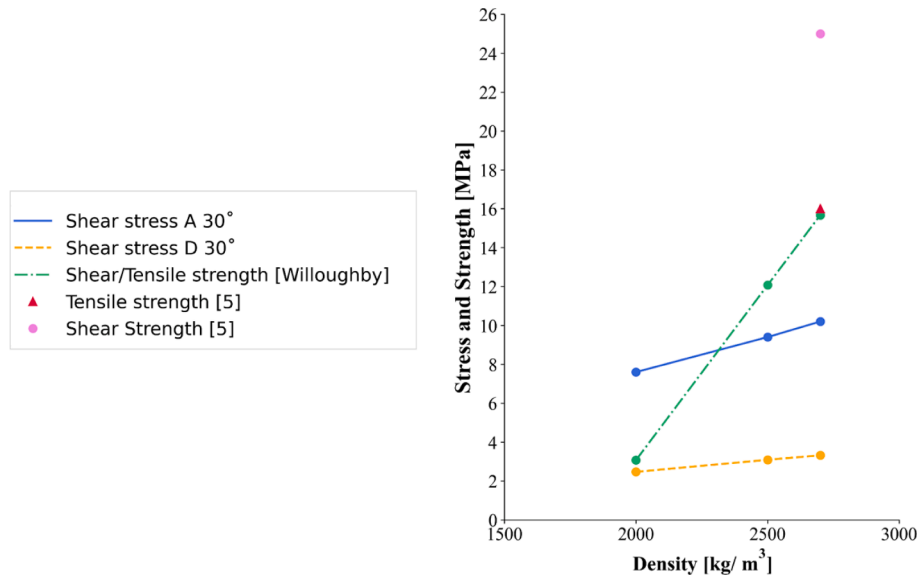
Fig. 25. Comparison between the maximum value of the shear stress calculated for case “A” and “D” with density equal to 2000, 2500 and 2700 kg/m³, the shear/tensile strength calculated using (5) for same density values, and shear and tensile strength specified by De Serio et al. [5] for the material used in the analyses.

by case “A” are above the shear strength for a density equal to 2000 kg/m³. Looking at the distance between the shear/tensile strength line and the two stress lines, this comparison gives an idea of the margin of safety of the analysed stair.

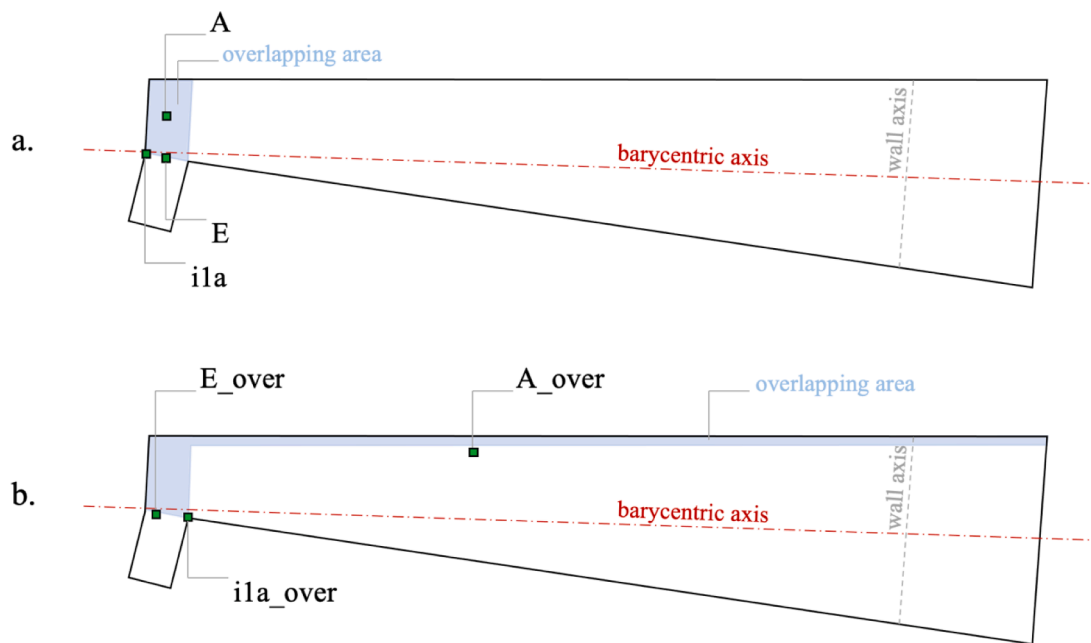
Fig. 27. Positions of the points of application of the forces transmitted by the tread above: a) Cases A, E and i1a (model with gaps between the treads); b) Cases A_{over}, E_{over}, i1a_{over} (model with overlapping treads).

geometric deviations generate cantilevering, the structure experiences lower bending moment values than i1a, where the point of application of the force reaches the maximum distance at the inner ring, Fig. 27a.
