# Fire resistance tests on beam-to-column shear connections

Pedro Palma, Andrea Frangi, Erich Hugi, Paulo Cachim and Helena Cruz

**Conference Paper**

2014

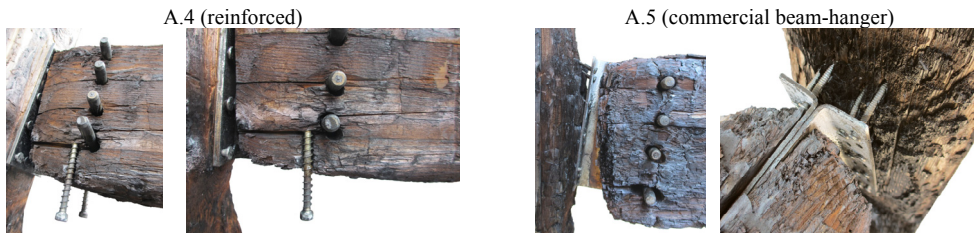
Figure 8. Connections A.4 and A.5 after the fire tests.

The connection reinforced with self-drilling screws (A.4) exhibited a fire resistance 5 minutes lower than the corresponding unreinforced connection (A.1). The reinforcement with self-drilling screws is an effective and widespread way to deal with the brittle splitting failures of the unreinforced connections loaded perpendicularly to the grain. However, as observed in a previous experimental campaign performed by the authors on the fire resistance of tension connections reinforced with self-drilling screws [7], the reinforcement screws also conduct heat into the cross-section (Figure 8), which in some cases compromises the fire resistance.

The common commercially available concealed beam-hanger (A.5) had gap of only 6 mm between the beam and the column (Figure 2.1 and Table 2), but a much lower estimated load-carrying capacity of the column-side of the connection (Table 3 and Figure 4a), although it failed on the beam-side at normal temperature. This commercial connection exhibit a fire resistance 5 minutes lower than the custom A.1 connection and failed in the column-side, with a failure mode similar to that of the connections A.2. However, the load in connection A.5 during the fire test was about 40% of the load-carrying capacity of the beam-side at normal temperature, instead of the 30% in connections A.1-3.

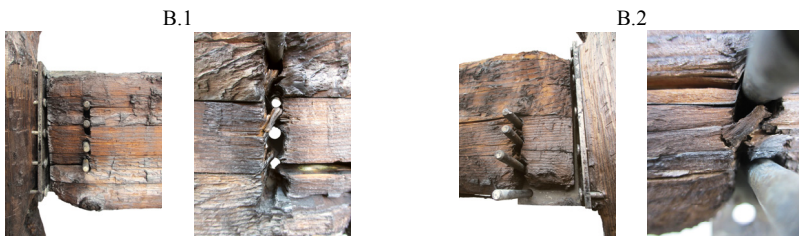
Figure 9. Connections B.1 and B.2 after the fire tests.

The influence of the failure mode can be analysed in the connections B.1 and B.2. These connections had smaller sized dowels (diameter of 8 mm) and showed brittle splitting (B.1) and ductile embedment/dowel failures (B.2) at normal temperature. In the fire tests, however, both typologies exhibited similar extensive embedment failures, followed by splitting. In fire, the smaller minimum dowel spacing perpendicular to the grain prescribed by EN 1995-1-1 (only  $3 \cdot d$ , compared to  $5 \cdot d$  parallel to the grain) leads to a premature failure when all the wood between the dowels is charred (Figure 9). Also the smaller minimum unloaded edge distances (connection B.2) perpendicular to the grain (only  $3 \cdot d$ , compared to  $7 \cdot d$  parallel to the grain) result in the complete charring of the wood surrounding the outermost dowels. Regardless of the failure mode at normal temperature, both connection typologies exhibited approximately the same fire resistance.

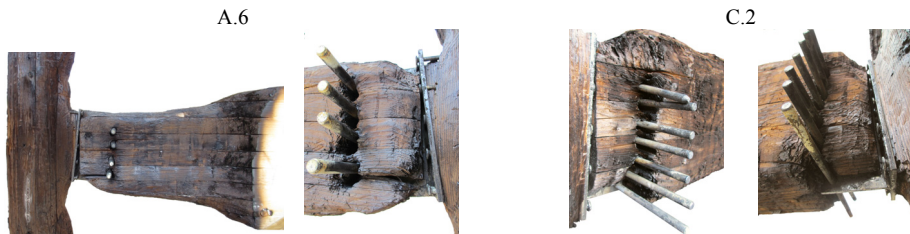
Figure 11. Connections A.6 and C.2 after the fire tests.

Connections A.6 and C.2 reached more than the estimated minimum 60 minutes of fire resistance [8]. Regarding connections A.6 (with 12 mm dowels), the long fire exposure charred the wood below and above the header steel plate nailed to the column, affecting the tension (nail withdrawal) and compression zones and allowing the steel plates to rotate (Figure 11, left). The dowels' end distance in connections C.1 (8 mm dowels) was smaller than in connections A.6 and, consequently, so was the moment in the header plate. Therefore, the rotation of the header plate was negligible. On the other hand, the charred depth in the zone between the dowels and the end of the beam was significantly higher than elsewhere in the beam, due to additional heat coming from the burning column-member and transferred by the dowels into the cross-section. After the wood between the dowels charred, the load was mostly transferred through the last dowel and it ultimately bent (Figure 11, right).
