Deterioration and conservation of monumental stones with polychrome relief decoration in upper Egypt

the archaeological remains of the Temple of
Merenptah

Arnold, Andreas; Zehnder, Konrad; Küng, Andreas (2002): Deterioration and conservation of monumental stones with polychrome relief decoration in upper Egypt. The archaeological remains of the Temple of Merenptah.- Zeitschrift für Kunsttechnologie und Konservierung, Jahrgang 16/2002, Heft 1, 5-35.

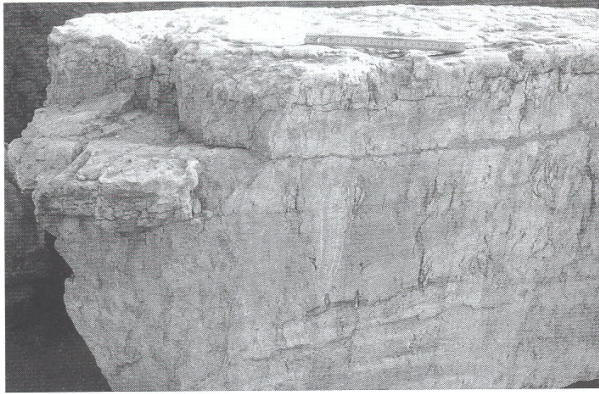
6. Partial view of a block of Qurna limestone. The bedding is horizontal. On the abutting face, the lamination of bright limestone and darker, slightly undulated marly to clayey layers, as well as darker vertical shrinkage cracks are clearly visible. The rough upper edge of the block has broken off along a clayey layer (bedding plane) and perpendicular shrinkage cracks. Width approx. 80 cm.

Outbreaks along edges with a size of several centimetres to decimetres. The fracture surface looks often conchoidal (shell-like). These are mechanical damages caused by punctual overload of the edges during split up, transport, and positioning of the blocks (fig. 6).

Fissures of different kinds. There are fissures along bedding, shrinkage cracks (fig. 6 and 7), fracturing due to tectonic movements and earthquakes, as well as fissures resulting from weathering.

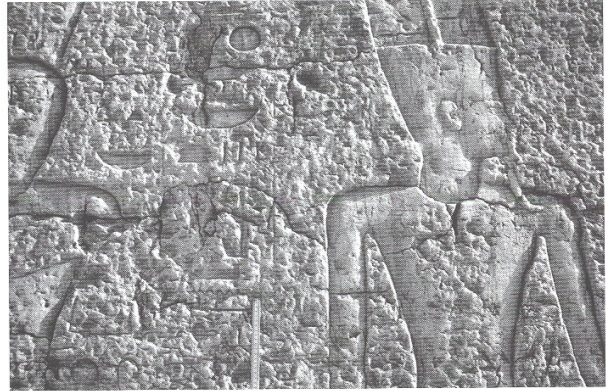
This bright beige looking limestone is a micrite, originating from mud of precipitated carbonate crystals and microfossils. It is composed of about 65% of calcite (micritic grains, microfossils and shell fragments of 1 to 20 µm in size), 10% of dolomite (rhombohedral grains of 5 – 20 µm), 15% of smectite and 10% of supplementary minerals, such as quartz, feldspar, hydrous ferric oxides and accessory carbonised organic material.³ The stone is very porous, soft and poorly consolidated. It shows original shrinkage cracks of up to some centimetres width and more than 1 m length in a distance of some centimetres to decimetres from each other. They form the typical polygonal patterns on the bedding plane and cross the stone approximately perpendicular to the bedding. They are partially open, partially filled with sediment mud from the geologic environment, and with mud, mortars from construction activity. The polygonal crack pattern is also visible on some carved and painted surfaces of the blocks (fig. 7).

7. Detail of a relief on a block of Qurna limestone. The bedding plane lies parallel to the image plane. Shrinkage cracks are visible e.g. on the chest and on the forehead of the figure on the right. Width approx. 1 m.

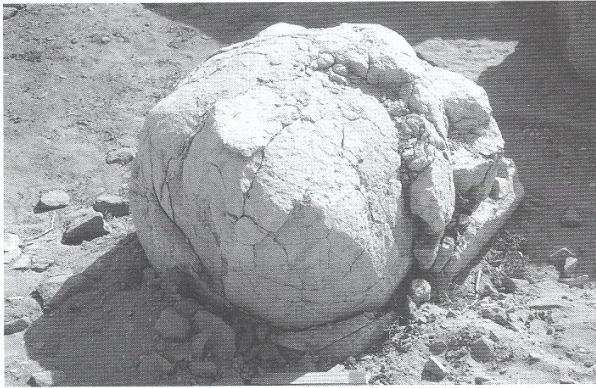
9. View of a weathered Block of Nubian sandstone. The bedding plane is slightly inclined to the right, the cross bedding in the upper part is rising to the right. The block is disintegrating along the bedding. Width approx. 70 cm.

Splitting and exfoliation parallel to bedding is very frequent in upper parts of the blocks. The fissures follow the silty and clayey layers between the banks, but also the fine cross bedding layers (fig. 9).

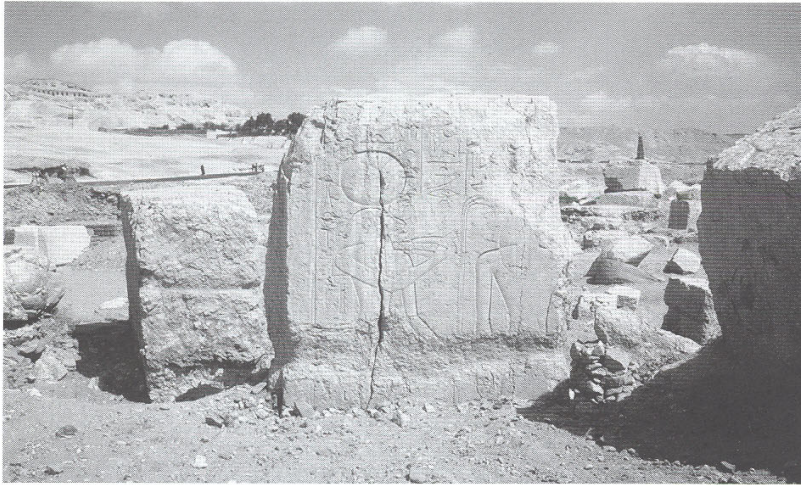
Flaking and spalling at the air soil interface. Several centimetres deep grooves have formed on blocks sticking partly in the terrain, in the zone where the stone surface intersects with the actual soil surface (fig. 11). This zone is 10 to 30 cm broad. It degrades by flaking and spalling and, in extreme cases, the stones split in depth and exfoliate parallel to bedding. In this zone, salts such as halite, gypsum and further hygroscopic compounds are accumulated. It may often look humid. Since the terrain has been ransacked and the affected blocks have prob-

11. Blocks of decorated Qurna limestone showing a horizontal groove due to intense weathering just above the former air-soil interface. The base of the blocks has already been uncovered from debris for conservation.

ably been displaced hundred years ago, we may conclude, that this rather intense decay has occurred within only about 100 years.

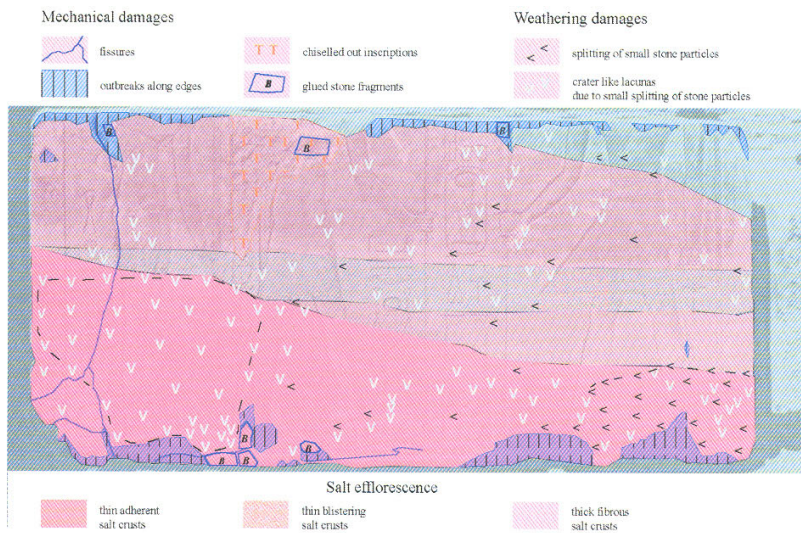
21. Graphic documentation of the damages

It became necessary to fill and fix cracks in the stone, to consolidate spalling stone surfaces, powdering paint layers, loose and detached gypsum mortars etc. That required the use of different fixing products. Based on the preliminary tests, the surfaces were cleaned mechanically as far as necessary, and salt crusts were weakened first by means of poultices and then removed mechanically. In particular situations, ammonium carbonate solutions were utilised to remove gypsum crusts. Large fissures were glued with epoxy resin, small fissures were fixed and filled with a lime slurry (seldom with addition of white cement). Loosened parts of the stone and the mortars and paintings were consolidated with Motema. Minute stone spalls were glued with UHU glue. Finally, unsightly spots created by repairs have been retouched by means of water colours.
