Are asymmetric metal markings on the cone surface of ceramic femoral heads an indication of entrapped debris?

Valet, Sebastian; Weisse, Bernhard; Kuebler, Jakob; Zimmermann, Martin; Affolter, Christian; Terrasi, Giovanni Pietro

BioMedical Engineering OnLine 13, <https://doi.org/10.1186/1475-925X-13-38>

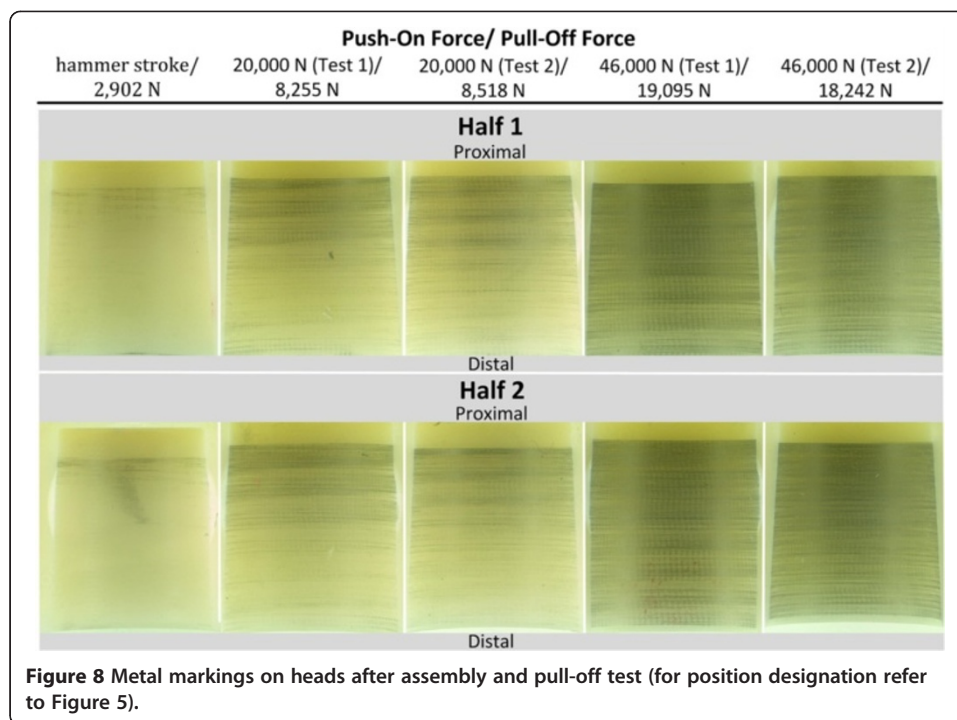
The analysis of the images allowed the following observations to be made:

- **Metal marking characteristics:** The metal marking appeared in a pattern of lines that resulted from manufacturing ridges on the surface of the titanium-taper.

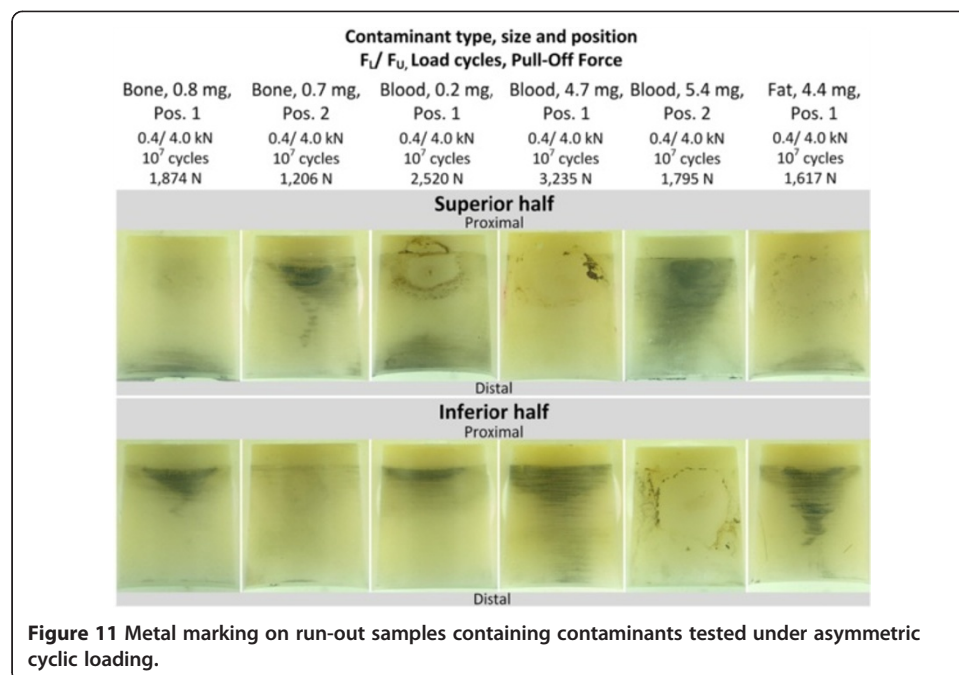
Figure 11 shows metallic marking on heads tested in a 40° configuration that had passed the run-out criterion (10 million load cycles) without failure. The average value of the force required to pull-off the heads from the differently contaminated taper was 2,041 N (n = 6, SD = 721 N, range = 2,029 N). The measured distance d_{GAP} was in a range of 2.5-2.7 mm.

Analysis of the conical surface of all heads with contaminants yields the following observations:

- **Distribution of metal marking in circumferential direction:** A strongly asymmetric distribution of metal markings is present along the circumferential direction.
- **Distribution of metal marking along taper axis:** Two regions of increased metal markings are present. Most intense marking appear in the proximal area at the opposite cone half of the contaminant, whereas slight markings are visible in the distal area on the superior and inferior side of the head.
- **Influence of contaminant position:** If the contaminant was placed on the opposite side of the cone (from superior to inferior side) it did not significantly change the degree and distribution of the resulting metal marking.
