# Experimental investigation of the sliding failure mode in full-scale squat reinforced concrete shear wall specimen

## Experimental investigation of the sliding failure mode in full-scale squat reinforced concrete shear wall specimen

**Abstract:** Squat-reinforced concrete shear walls are used as a gravity and lateral load resisting system in structures such as buildings and nuclear power plants. Due to their low aspect ratio, they are prone to shear or sliding failure. A shear wall was subjected to a cyclic test at the new Multi-Axis Sub-Assemblage Testing (MAST) facility at ETH Zurich. The shear to span ratio was 0.51 and a vertical load of 5.61% of the axial capacity of the wall was applied. The wall had a sliding failure, with a peak load capacity of 2760 kN. Digital Image Correlations (DIC) results show how the shear crack developed until sliding started and, from this point on, the majority of the wall deformation originated in the wall-foundation interface. Sliding displacements consisted of more than 50% of the total displacements of the specimen in large-amplitude cycles.

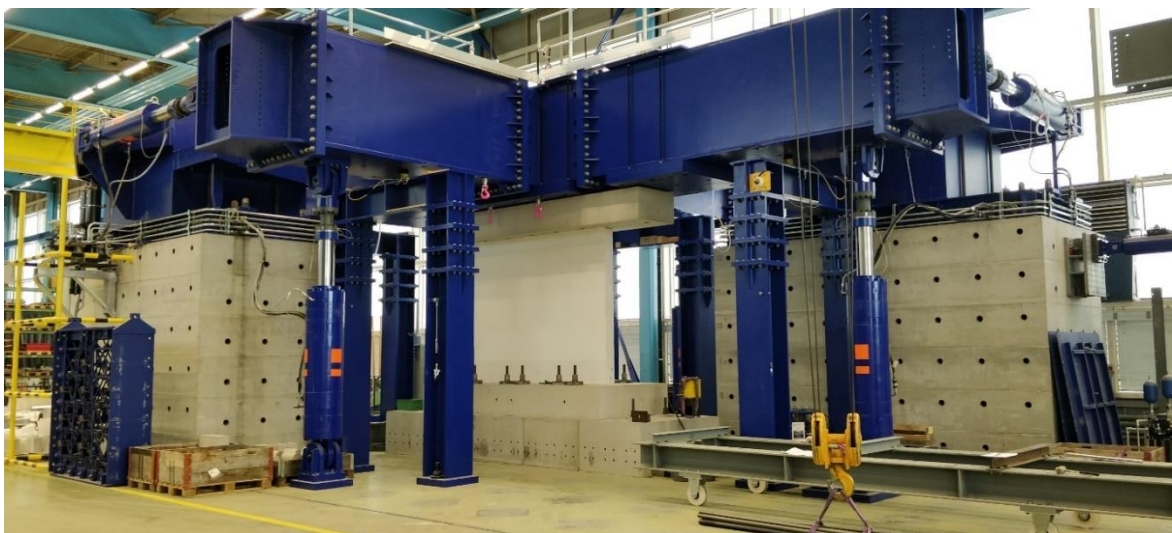
The ETHZ MAST (Multi-Axis Sub-Assemblage Testing) Facility combines actuators, reaction walls, a crosshead, and a strong floor into an optimized machine that can handle a full node-wise coupling (3 translations and 3 rotations), between a numerical and physical sub-domain of a hybrid model (Abbiati and Stojadinovic 2018). It has 4 actuators in the Z direction (2 MN capacity each), 4 in X (1 MN each), and 2 in Y (1 MN each), and a crosshead of steel sections that transfers the loads from the actuators to the specimen (Figure 1).

Fig. 1 – ETHZ MAST Facility

The specimen was fixed to the strong floor and the steel crosshead with steel rods post-tensioned to 1 MN (18 in the bottom and 12 in the top, Figure 1). As the test was conducted in-plane, torsion, and out-of-plane translation and rotation of the specimen were constrained. The control point of the test, where the displacements, rotations, forces, and moments are computed, was the center of the bottom flange of the steel crosshead, which is 3.25m above the interface wall foundation. The test was run in a fixed-fixed condition, which means that the system could not rotate at the control point, and therefore the shear-to-span ratio applied to the wall is  $M/VL = 0.51$ .

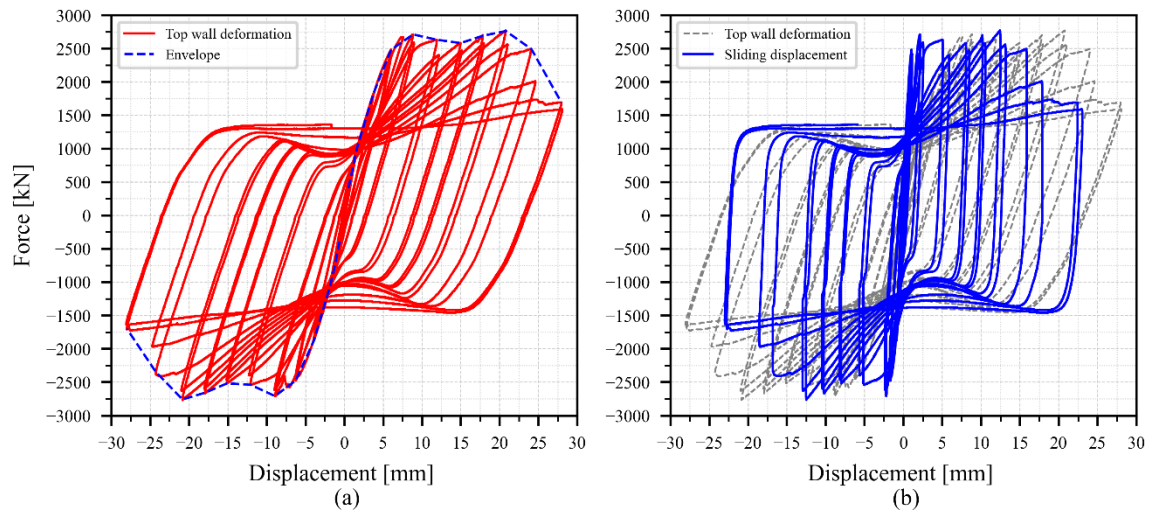
The control point horizontal force-displacement hysteresis curves are shown in Figure 3. Table 1 shows the displacement in each cycle, along with the proportion of the measured sliding deformation in the wall-foundation interface. The peak resistance was 2760 kN at a displacement of 20.81 mm (6.40‰ drift)

From cycle N°7 (11.93 mm), upon each load reversal, there is a plateau in which no increment of force is needed to deform the wall due to sliding. Sliding increased after each cycle, and in the last two cycles (N° 11 and 12) the hysteresis loop shape is very similar to a frictional damper. Previous sliding failures with no or low axial loads do not show this behavior: the axial load applied in this test engaged the friction at the wall-foundation interface to provide lateral load resistance.

Figure 3: Control point horizontal force-displacement hysteretic curve: (a) total displacement; (b) sliding component of the total displacement.

After the sliding failure was triggered, the sliding displacement increased in the second cycle at each displacement amplitude (Table 1). This is because of the degradation of the aggregate in the interface, and it is consistent with the effect and formulation described by Trost (2018).
