Conference Paper

THE POTENTIAL OF REVERSE ENGINEERING AND DIGITAL FABRICATION FOR THE REPAIR OF HIGH-TECH ARCHITECTURE

M. Brenner* 1, L. Vandenabeele 2, S. Langenberg 1

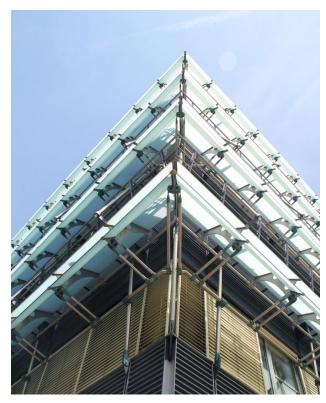
Figure 1. View of the "CLA" façade from Tannenstrasse

The university building "CLA" at Clausiusstrasse in Zurich provides laboratory and office spaces for the Department of Mechanical and Process Engineering and is part of the central campus of ETH Zurich. It was designed in 1986 by Fosco Fosco-Oppenheim Vogt architects and was built in two stages between 1990-98. (Fig. 1)
